Errata Sheet

SLG46532

Revision 0.16

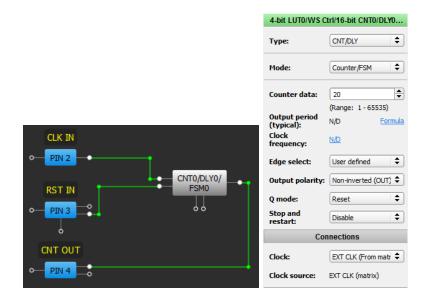
If the Counter Reset appears at the time very close to a rising edge of the clock signal while clock signal generation (for example OSC operation) there is a possibility that the Counter Data of the Counter is reset incorrectly and the counter end signal (HIGH pulse) may appear faster than expected. This phenomena appears more frequently the higher clock frequency is.

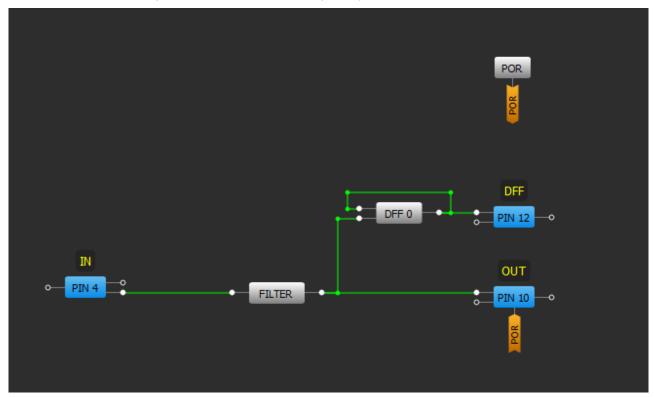
If clock type high frequency input comes in, the FILTER cell may not filter out it. There are several factors like input frequency, duty cycle and LOW duration in such signal that may lead to its passing through FILTER block.

Channel 1 (yellow/top line) – PIN#4 (IN) Channel 2 (light blue/2nd line) – PIN#10 (OUT) Channel 3 (magenta /3rd line) – PIN#12 (DFF)

Currently there is no workaround for this issue. Filter block is good at filtering short spontaneous glitches. It is intended to be used in series connection before the delay cell to avoid its latching (see issue #2).

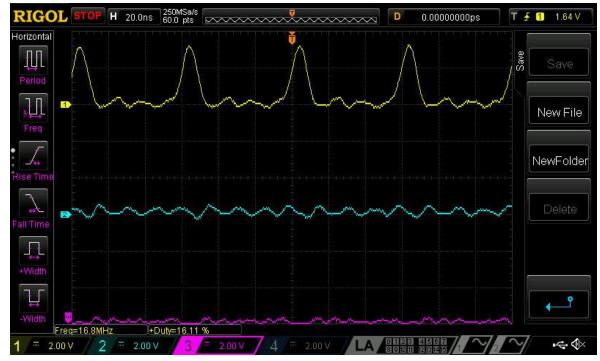
1. Period is 60ns. Pulse width is 10ns DC=16.7% (Correct functionality)

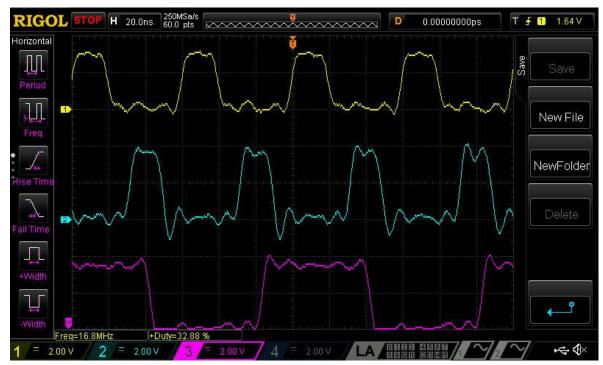
2. Period is 60ns. Pulse width is 20ns DC = 33.3% (Incorrect functionality)

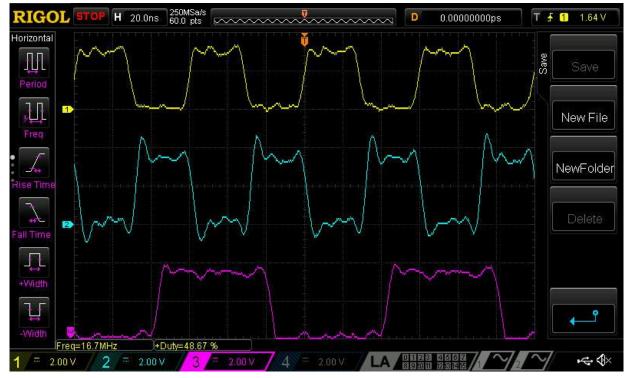
3. Period is 60ns. Pulse width is 30ns DC=50% (Incorrect functionality)

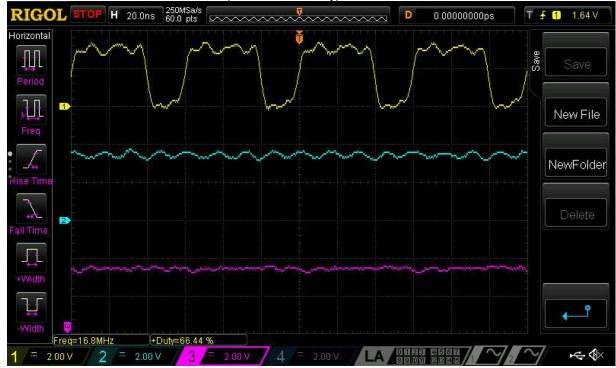
4. Period is 60ns. Pulse width is 40ns DC=66.67% (Correct functionality)

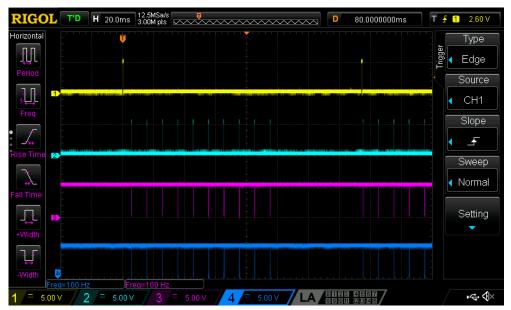
Asynchronous interaction between the CNT/DLY clock input and the I²C latch signal (generated by an I²C read command of the CNT/DLY block's count value) can result in an incorrect I²C data read. The CNT/DLY block will count accurately, but the count value transferred into the block's I²C read register might be loaded incompletely if the I²C latch signal and the clock input occur at about the same time.

The example data capture below shows ten periodic I^2C reads of CNT2/DLY2 configured to count down at about 16 clocks per read. The sixth read sample erroneously shows a value greater than that of the fifth. The seventh sample reads as if the previous I^2C error never occurred - the difference from the fifth sample (176) to the seventh (143) is 33 clocks or 16 clocks + 17 clocks as expected.

Channel 1 (yellow/top line) – PIN#2 (CNT2/DLY2 Out) Channel 2 (light blue/2nd line) – PIN#1 (I2C Read Triggers) Channel 3 (magenta /3rd line) – PIN#8 (I2C SCL) Channel 3 (dark blue /4th line) – PIN#9 (I2C SDA)

If the possibility of incorrect I²C data reads can't be accommodated for by external software checks, one can guarantee proper operation by stopping the CNT/DLY block's clock during I²C reads through one of the following methods: by disabling the oscillator block, by reconfiguring the CNT/DLY block's clock source, or by gating an external clock using a LUT (Look-up Table) in the signal matrix. After disabling the CNT/DLY block's clock, the count registers can be read without error. Please note that this workaround will add the I²C read and processing time to the counter's overall clock period.

The best workaround depends on the resource constraints of the application. If the oscillator block doesn't clock other logic elements within the design, a matrix output can be used to manually power down the oscillators for the I²C read. When the CNT/DLY block's clock source is routed internally from the oscillator block, I2C commands can temporarily reconfigure the CNT/DLY block's clock source registers to select "Ext. CLK. (From Matrix)." This action will disable the clock by connecting it to ground. If the CNT/DLY block is clocked from the signal matrix, a LUT can be used to gate the clock during an I²C read.
