SLG46583

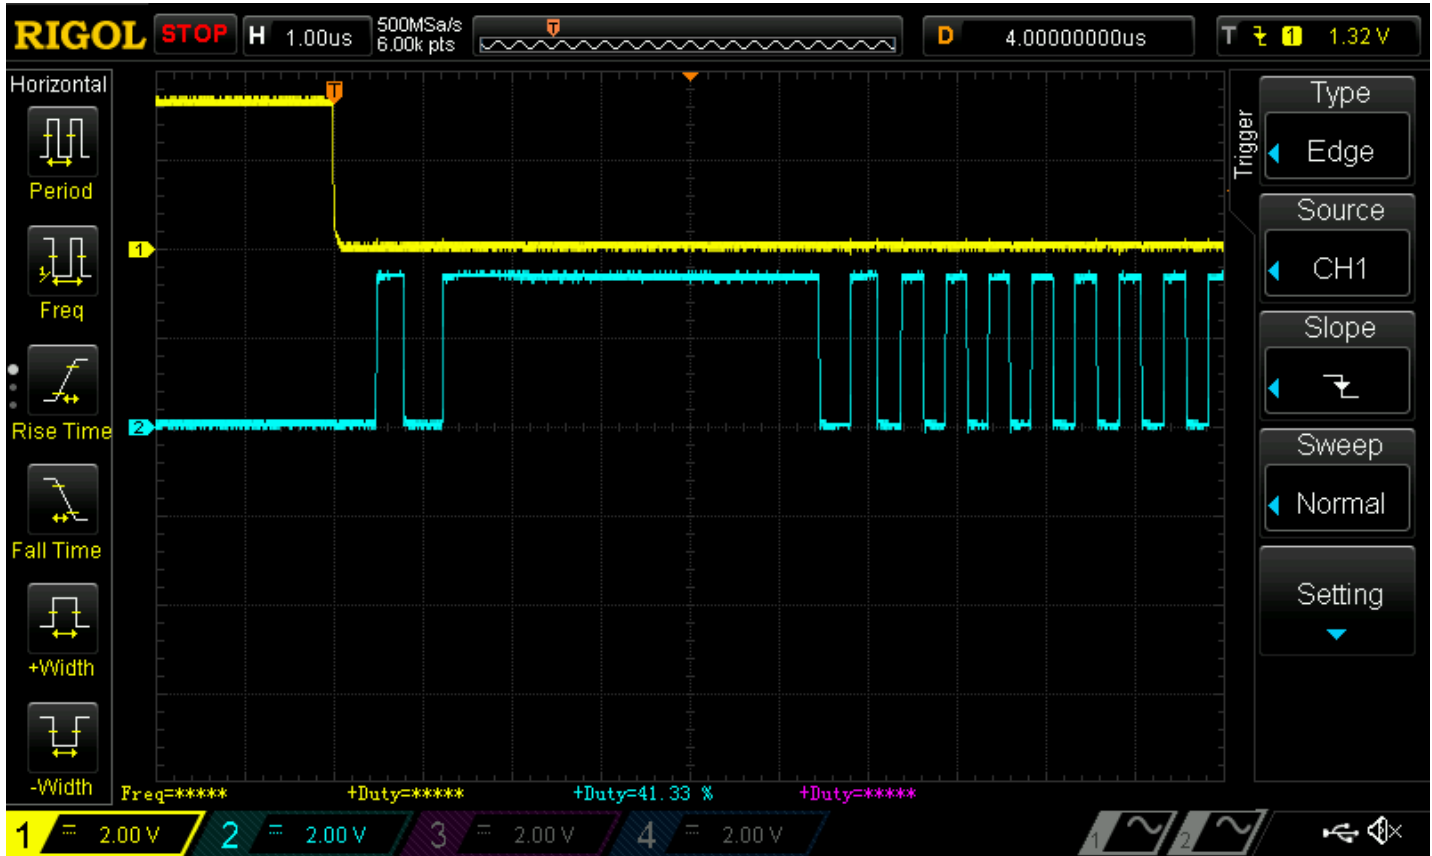
2MHz OSC has an additional ~ 9 cycles settling period. Higher VDD shows longer settling time.

Channel 1 – OSC Power Down; Channel 2 –OSC output

Such behavior will lead to substantial error in period calculations if the delay time is relatively small.

- Enable Fast Start-up option. Fast Start-up means forcing bias ready at the power-up instead of automatic enabling at OSC event. The standby current consumption difference between Fast start-up disabled and enabled is only an additional 300 nA.
- Use the “Force power on” OSC power control option to make the OSC operate at all times. However, this will cause increased constant current consumption.

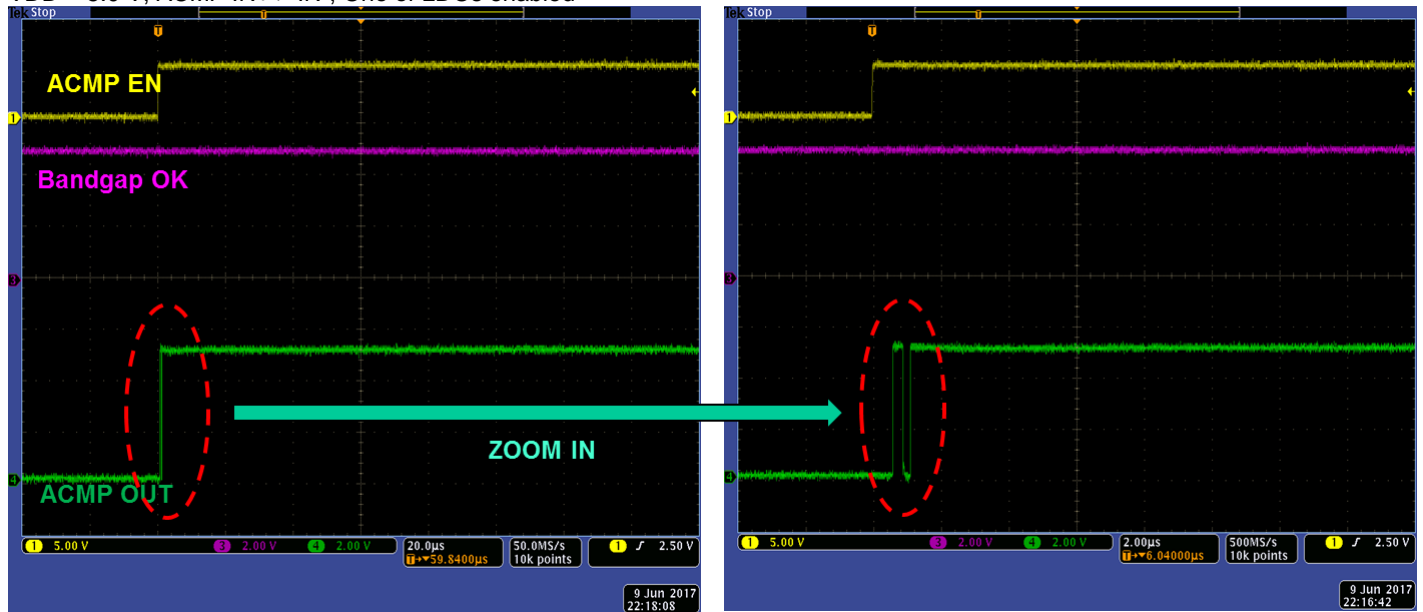
After power-up, if LDO is enabled earlier than ACMP, its output may generate a glitch.

VDD = 5.0 V, ACMP IN+ > IN-, One of LDOs enabled

Because BG_OK is already released by LDO, there is no gating signal. Depending on the ACMP VREF condition & the positive input value, it is possible for the ACMP to have a glitch. Subsequently, the other ACMP will not have an issue unless the customer repeats LDO enable first and ACMP later during power stable.

- Use both edge delay on the output to filter out the glitch.

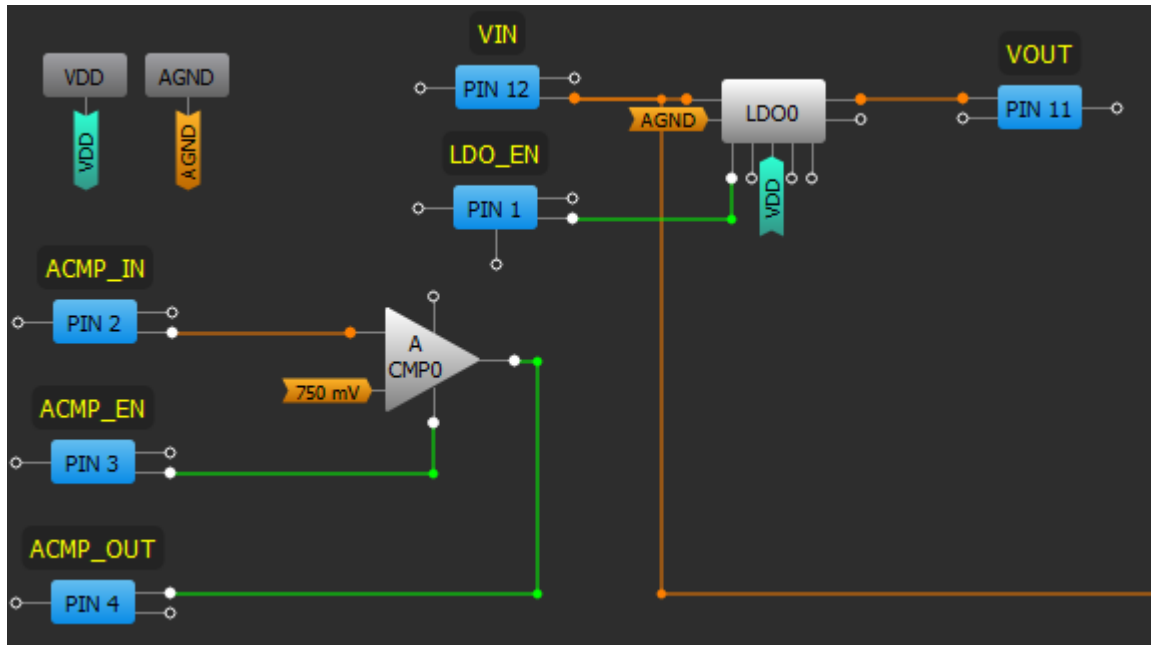
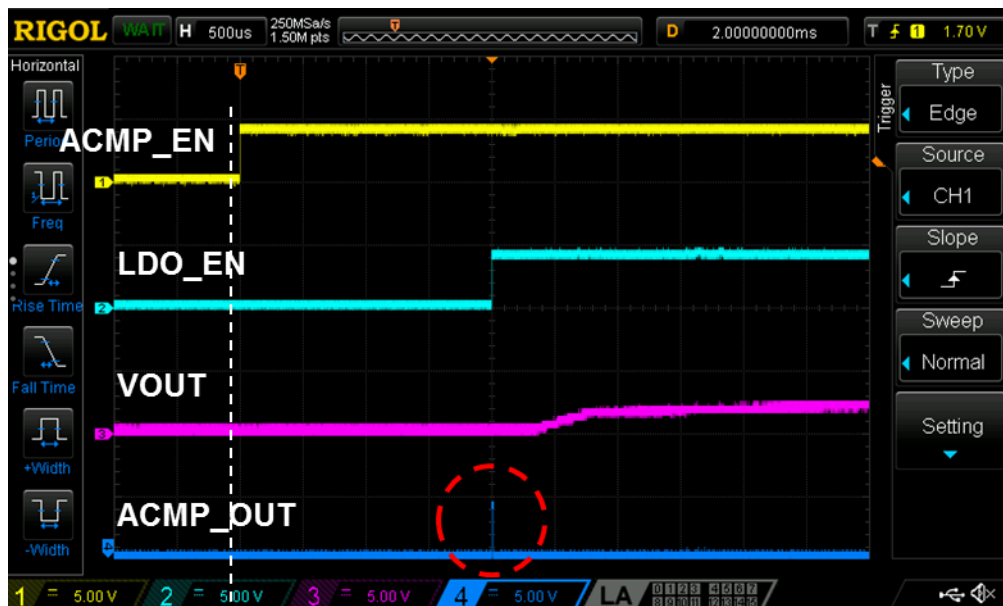
If an LDO's Low Power Mode is selected (for example tied to VDD) a glitch may appear on the ACMP's output after the first LDO is enabled. When the first LDO is turned on, the Low Power Mode switch causes a drop in the internal bandgap voltage that is used to derive the ACMP reference voltages.

- Use both edge delay on the output to filter out the glitch.
- Use some logic to avoid turning on Low Power Mode before enabling LDO and powering up the ACMP. Example is shown below.

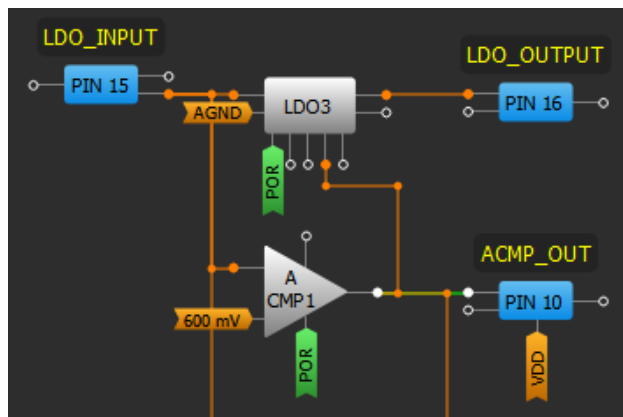
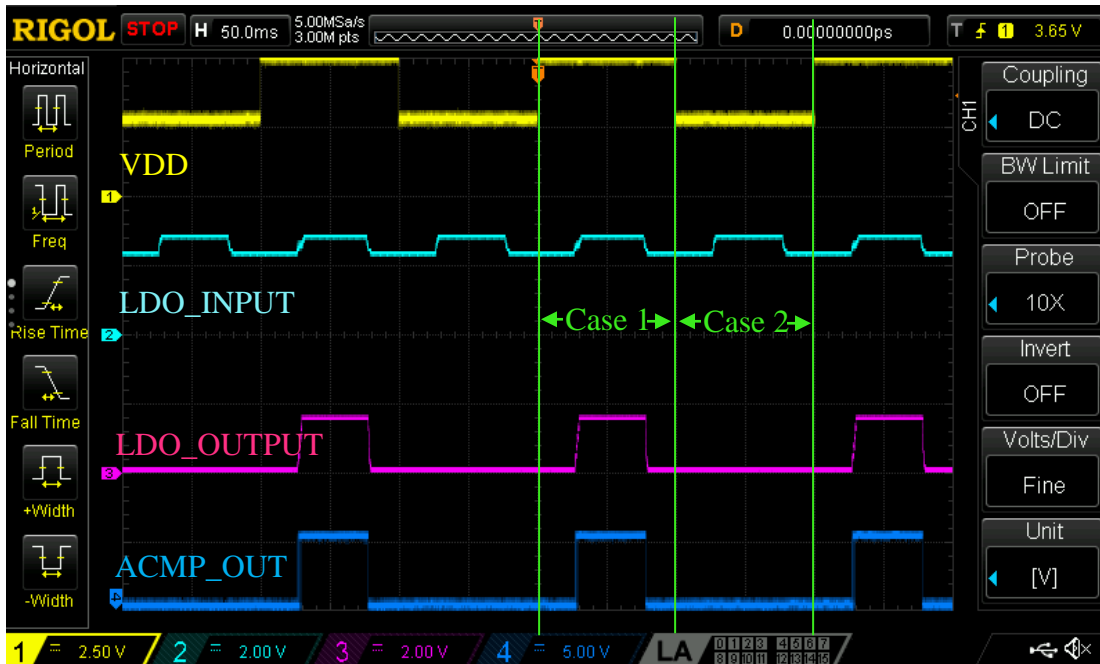
If an LDO’s VIN pin (LDO_INPUT) has an internal connection (depicted with an orange wire) to the ACMP’s IN+ port, the ACMP’s output may give an erroneous result with respect to the LDO’s input voltage. The switch between the LDO’s VIN pin and the ACMP’s IN+ port is implemented using an NMOS-only based transmission gate with its gate controlled by logic supplied from VDD. As a result, this switch is unable to pass LDO input voltages that are close to VDD. This can result in the ACMP’s IN+ port seeing a lower voltage than the actual voltage present at LDO_INPUT. This lower input voltage may cause the output of the ACMP to behave unexpectedly.

If the LDO’s UVLO feature is enabled, the ACMP’s output will cause unexpected LDO behavior that results from the previously described transmission gate voltage drop.

Case 1: Proper Behavior at VDD = 5V;

With a 5V VDD, the NMOS transmission gate passes the 2.25 and 2.75V LDO_INPUT pin voltages to the ACMP's IN+ port. When the input voltage exceeds the 2.4V IN- threshold of the ACMP, the LDO is enabled.

Case 2: Erroneous Behavior at VDD = 2.75V;

When the VDD is reduced to 2.75V, the NMOS transmission gate is unable to pass LDO_INPUT's full magnitude to the ACMP's IN+ port. Since the IN+ port of the ACMP doesn't exceed the 2.4V IN- threshold, the ACMP's output stays low and keeps the LDO disabled.

- If the GreenPAK's VDD is always powered up before the LDO's VIN input, you can externally short the LDO's VIN to another dedicated analog input pin for the desired ACMP.

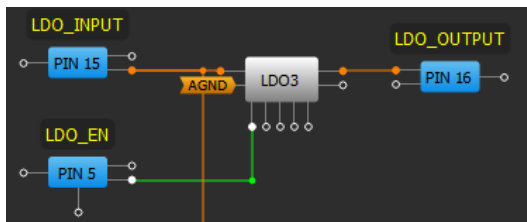
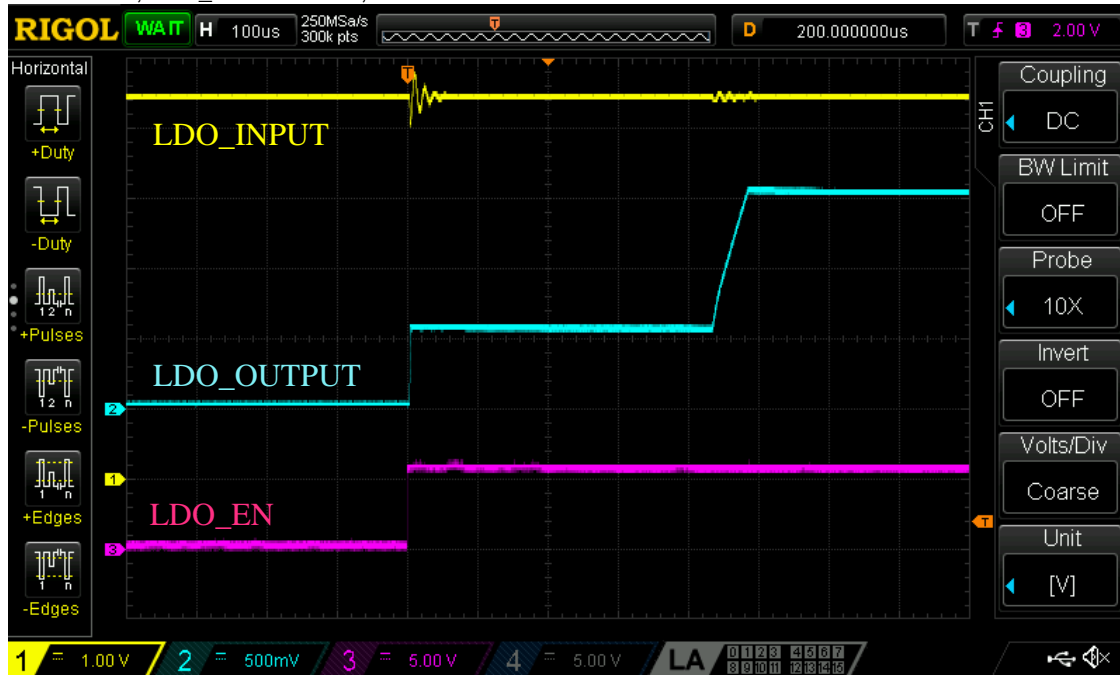
When a GreenPAK's first LDO is enabled, the LDO's VOUT will step to a non-zero voltage during its 500 μ s wait time. The magnitude of this step is directly proportional to the LDO's VIN and the GreenPAK's VDD. With a large LDO input voltage and VDD, this step can exceed 500mV.

VDD = 5.5V, LDO_INPUT = 5.5V, All other LDOs Disabled

- If your GreenPAK design has an unused LDO, you can reduce the magnitude of this voltage step by keeping an unused LDO enabled in high power mode.

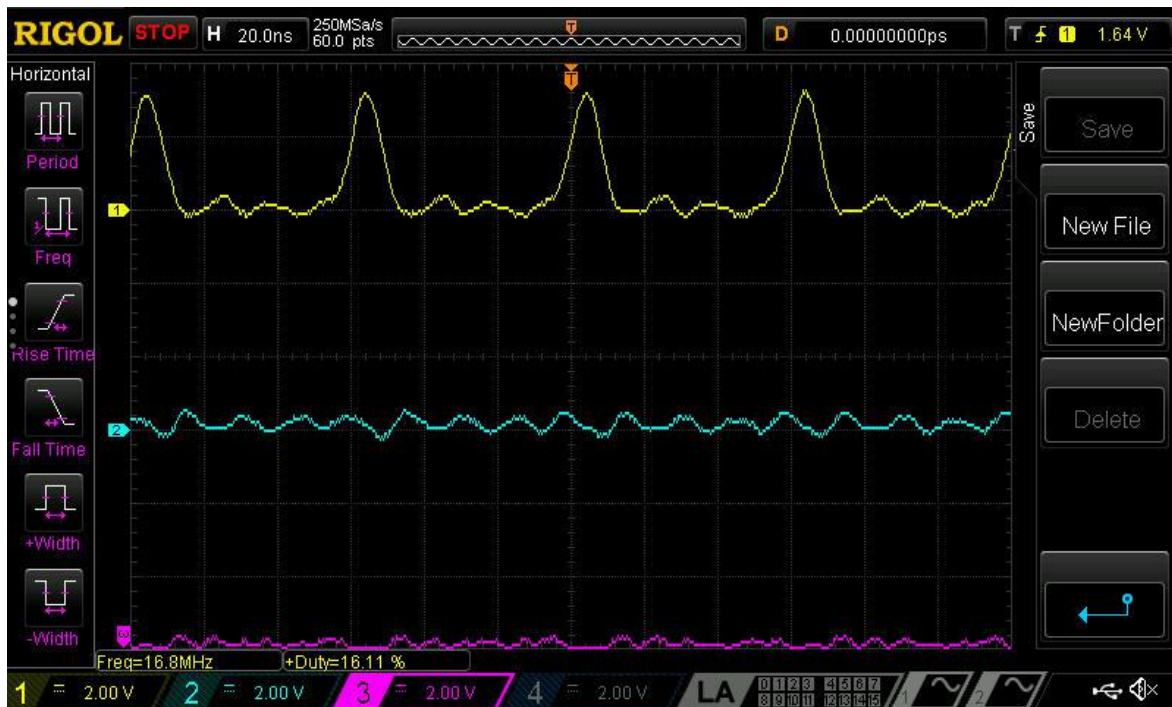
Channel 1 (yellow/top line) – PIN#4 (IN)
 Channel 2 (light blue/2nd line) – PIN#10 (OUT)
 Channel 3 (magenta /3rd line) – PIN#12 (DFF)

1. Period is 60ns. Pulse width is 10ns DC=16.7% (Correct functionality)

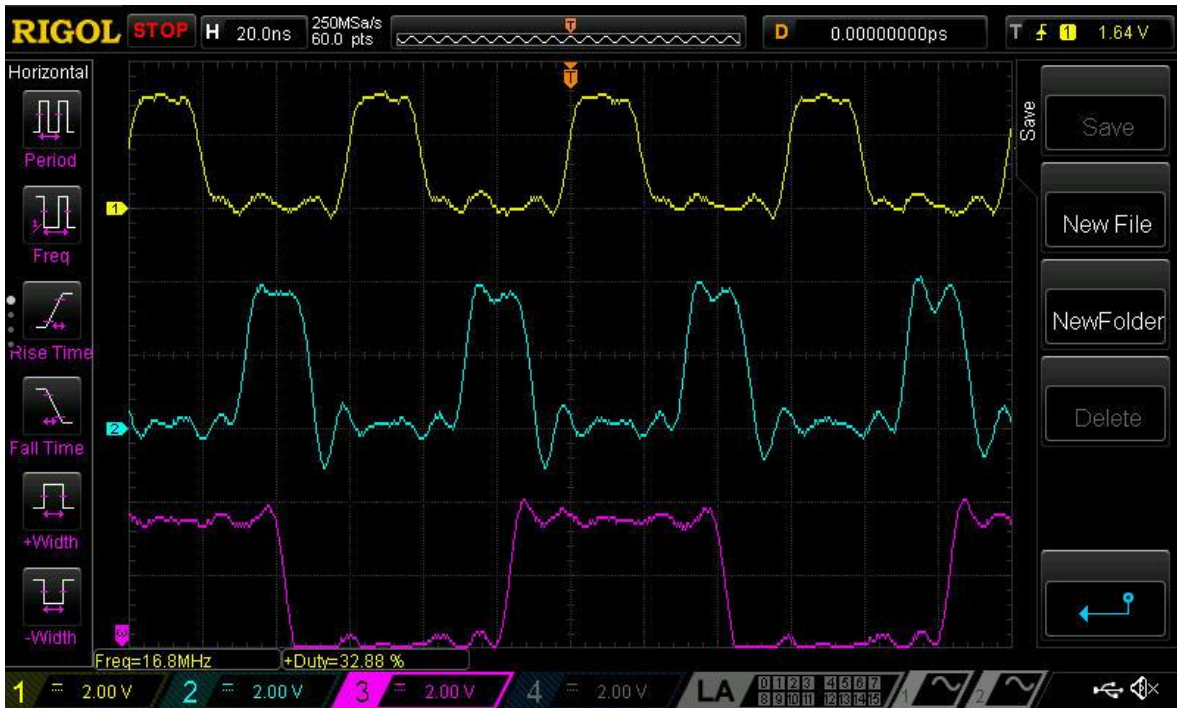
If the FILTER cell's input signal contains multiple consecutive pulses within short time intervals, the FILTER cell may not filter the input pulses as expected. The errant behavior applies only to repeated input pulses and depends on both their frequency and duty cycle.

2. Period is 60ns. Pulse width is 20ns DC = 33.3% (Incorrect functionality)

Currently, there is no workaround for this issue. The FILTER block correctly filters isolated glitches, but it shouldn't be used to filter repetitive, high frequency input signals.

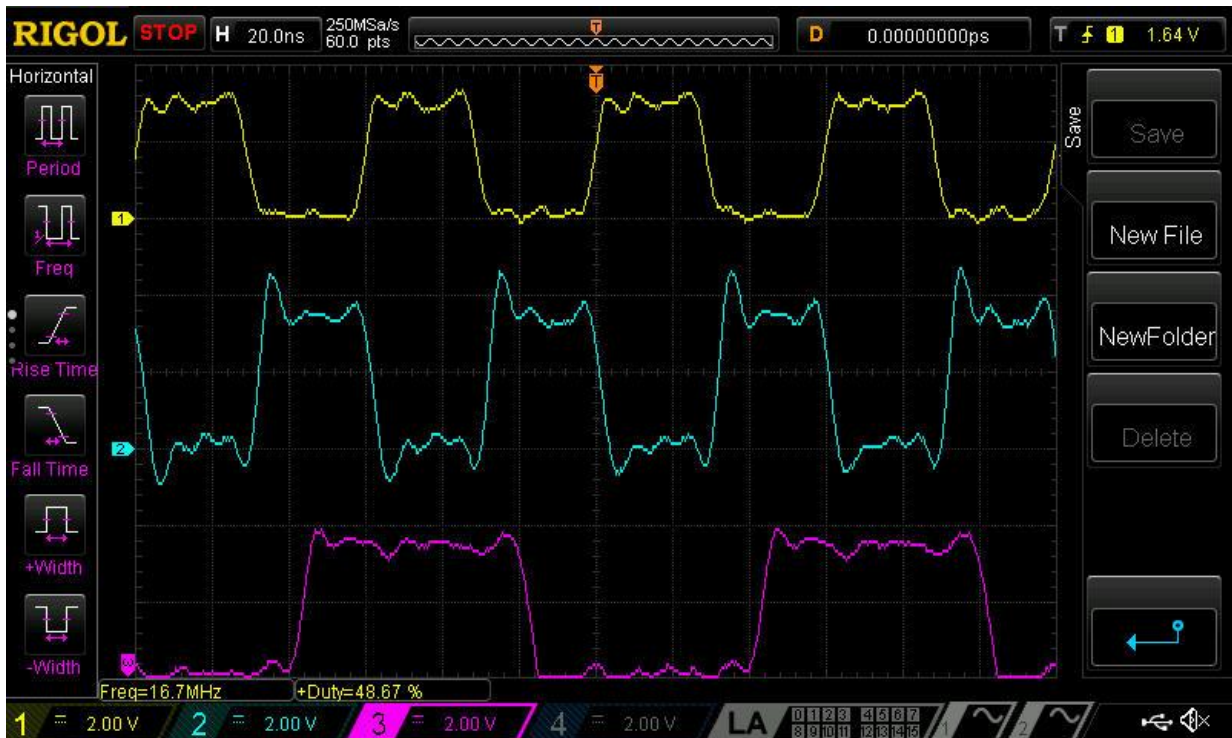
3. Period is 60ns. Pulse width is 30ns DC=50% (Incorrect functionality)

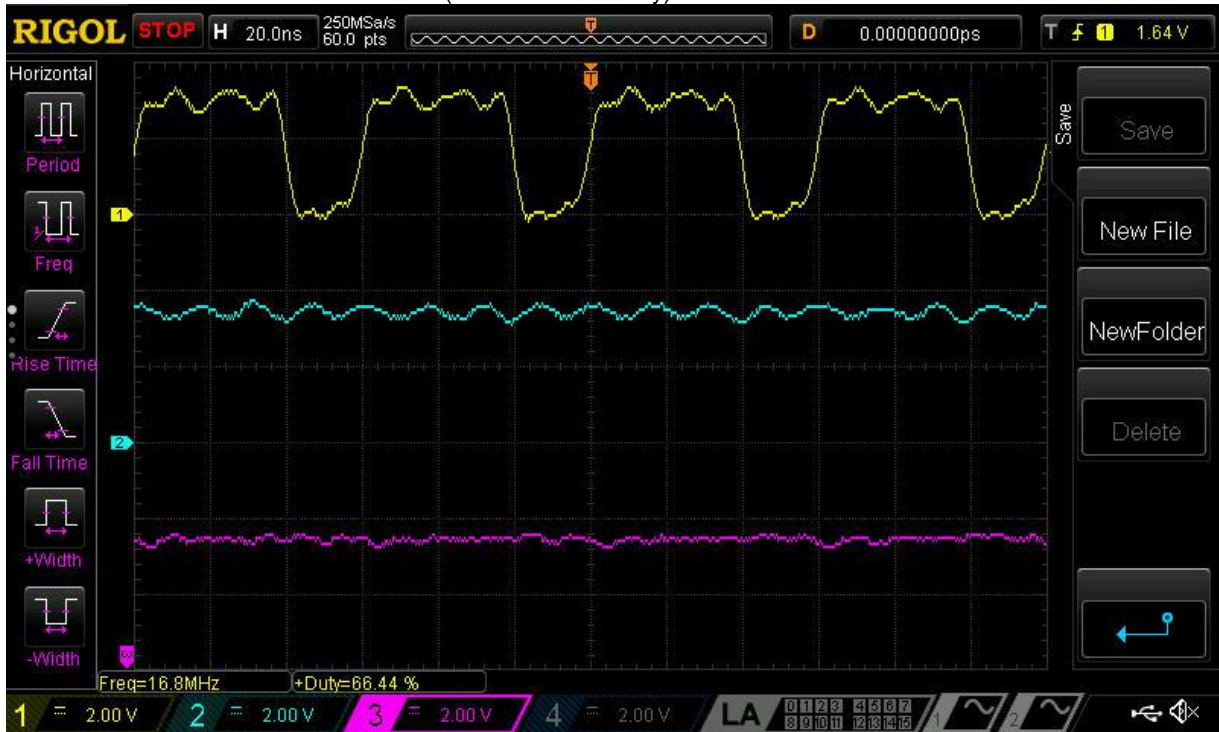
4. Period is 60ns. Pulse width is 40ns DC=66.67% (Correct functionality)

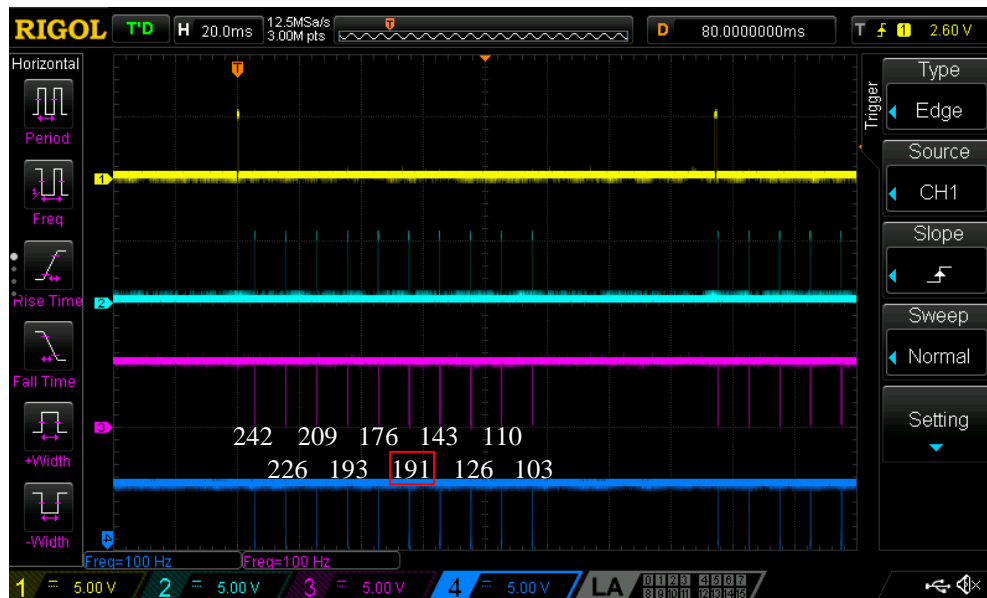
Asynchronous interaction between the CNT/DLY clock input and the I²C latch signal (generated by an I²C read command of the CNT/DLY block's count value) can result in an incorrect I²C data read. The CNT/DLY block will count accurately, but the count value transferred into the block's I²C read register might be loaded incompletely if the I²C latch signal and the clock input occur at about the same time.

The example data capture below shows ten periodic I²C reads of CNT2/DLY2 configured to count down at about 16 clocks per read. The sixth read sample erroneously shows a value greater than that of the fifth. The seventh sample reads as if the previous I²C error never occurred - the difference from the fifth sample (176) to the seventh (143) is 33 clocks or 16 clocks + 17 clocks as expected.

- Channel 1 (yellow/top line) – PIN#2 (CNT2/DLY2 Out)
- Channel 2 (light blue/2nd line) – PIN#1 (I2C Read Triggers)
- Channel 3 (magenta /3rd line) – PIN#8 (I2C SCL)
- Channel 3 (dark blue /4th line) – PIN#9 (I2C SDA)

If the possibility of incorrect I²C data reads can't be accommodated for by external software checks, one can guarantee proper operation by stopping the CNT/DLY block's clock during I²C reads through one of the following methods: by disabling the oscillator block, by reconfiguring the CNT/DLY block's clock source, or by gating an external clock using a LUT (Look-up Table) in the signal matrix. After disabling the CNT/DLY block's clock, the count registers can be read without error. Please note that this workaround will add the I²C read and processing time to the counter's overall clock period.

The best workaround depends on the resource constraints of the application. If the oscillator block doesn't clock other logic elements within the design, a matrix output can be used to manually power down the oscillators for the I²C read. When the CNT/DLY block's clock source is routed internally from the oscillator block, I²C commands can temporarily reconfigure the CNT/DLY block's clock source registers to select "Ext. CLK. (From Matrix)." This action will disable the clock by connecting it to ground. If the CNT/DLY block is clocked from the signal matrix, a LUT can be used to gate the clock during an I²C read.

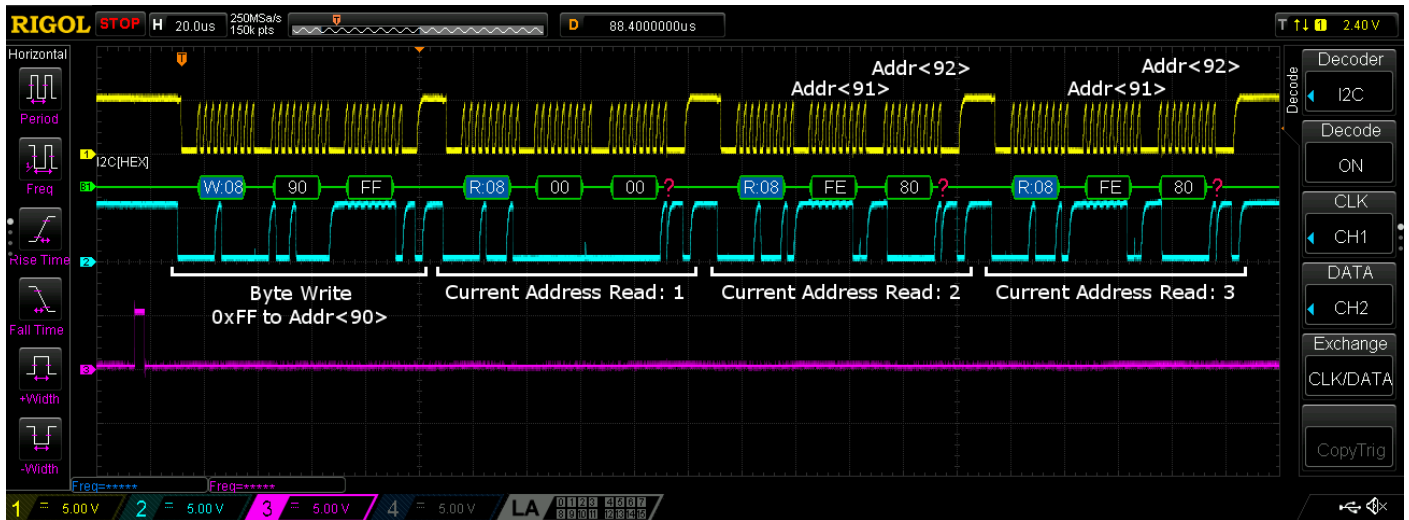
The first “Current Address Read” or “Sequential Read” command following an I²C “Byte Write” or a “Sequential Write” command will produce incorrect data. Additional read commands will return the expected data. See the waveform below for more information.

Channel 1 (yellow/top line) – PIN#8 (SCL)
 Channel 2 (light blue/2nd line) – PIN#9 (SDA)
 Channel 3 (magenta /3rd line) – I2C Software Trigger

Note: In the GreenPAK test design, Addr<91> and Addr<92> expect FE and 80 respectively.

If possible, use the “Random Read” command as described in the datasheet for SLG46583. This command will output the correct data.

If you expect consecutive reads of the same register, we recommend sending a “Random Read” command to the register preceding the register of interest. After the “Random Read” command finishes, the chip’s register pointer will increment to the desired register and the following “Current Address Read” or “Sequential Read” commands will produce the correct data. Note that the “Current Address Read” and “Sequential Read” commands don’t increment the GreenPAK’s register pointer.
