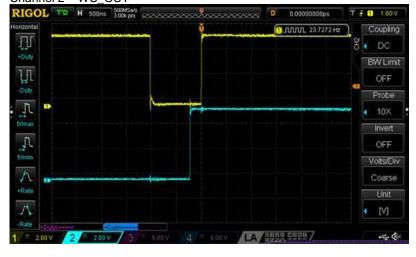
The output of the ACMP incorrectly goes low even when IN+ is greater than IN- if the RING OSC is active when the WS signal rises

Avoid using the RING OSC with the WS Controller, or add a filtering block on the ACMP output to filter out the glitch.

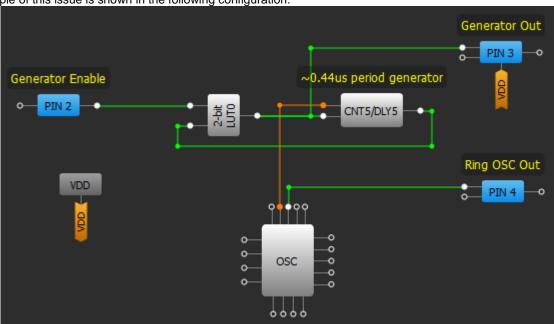
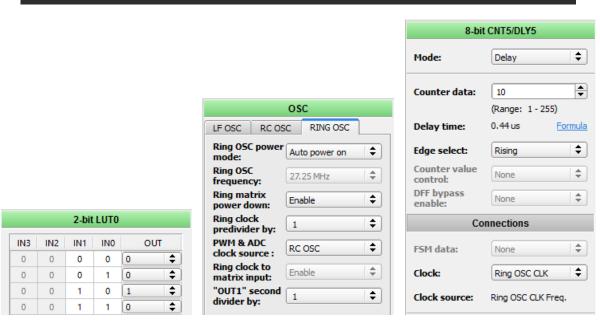
The Ring OSC has a longer settling time when configured as Auto Power On in the designs that have very short Ring OSC disable time. An example of this issue is shown in the following configuration:

The configuration shown above generates a periodical signal with a frequency defined by the Delay cell and started by a high signal on PIN2. The issue becomes apparent in a longer settling time when the scheme generates short pulses (Delay is configured as a rising edge delay only). See waveform below.

- Set Ring OSC power mode to "Force Power On"
- or, Set Turn on by register option in BG (Band Gap) block as "Enable"

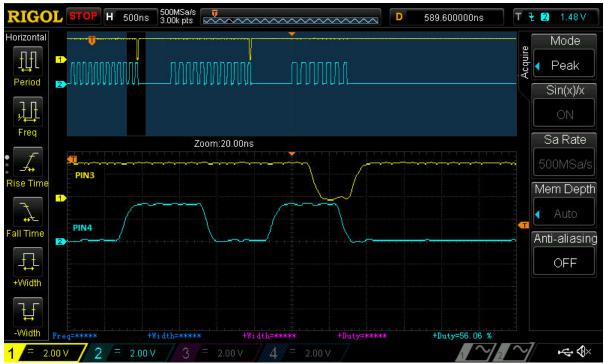
Channel 1 - 2-bit LUT0 output; Channel 2 - Ring OSC output

Such behavior will lead to substantial error in period calculations if the delay time is relatively small.

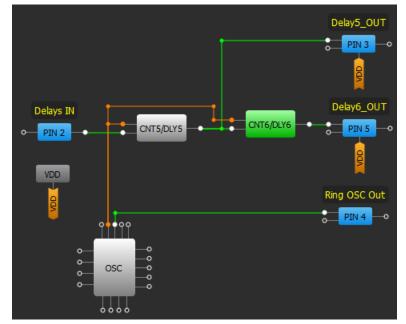
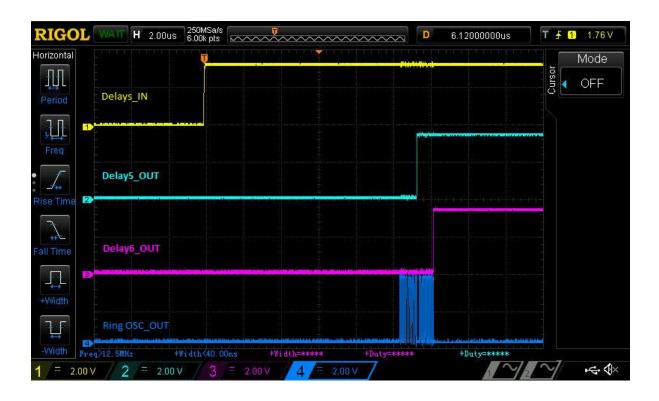
A similar situation can occur while using two connected delays (all edge detect types except for a pair "Rising edge DLY - Falling edge DLY").

In the following example, Delay5 and Delay6 are configured in the same way. However, Delay5 time is 11.4us instead of expected 0.4us (Delay5 time).

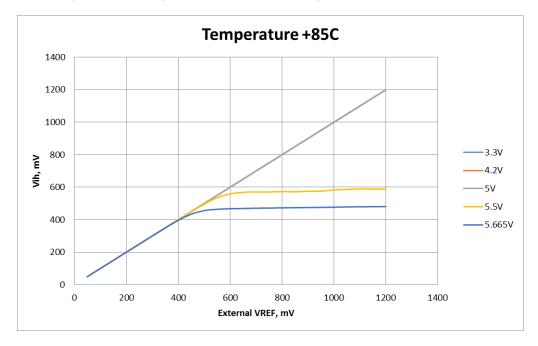
When using external Vref source, the ACMP comparison may happen at wrong threshold if the external Vref voltage is higher than a particular value (please see figure below) at high VDD values ( > 5V) and high temperature.

Avoid using ACMPs in such conditions.

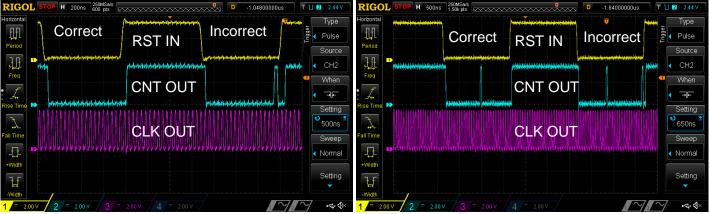
If the Counter Reset occurs at a time very close to a rising edge of the clock signal during clock signal generation (for example OSC operation), there is a possibility that the Counter Data of the Counter is reset incorrectly and the counter end signal (HIGH pulse) may appear faster than expected. This phenomena appears more frequently the higher the clock frequency is.

Synchronize RESET input of the Counter with its CLK using 2 DFF cells as shown in the image below.

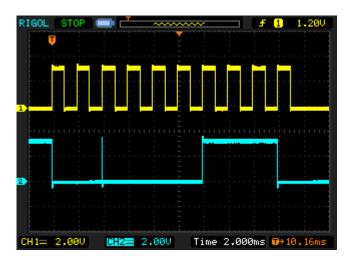
DCMP's OUT+ output may have a glitch when the input data is changed. This issue appears more frequently the higher DCMP clock is.

For example, DCMP IN+ sources from FSM0 and IN- from Register0. DCMP is clocked from the Ring OSC.

Synchronize the data source clock with the DCMP clock source using 2 DFF cells as shown in the images below.
