SLG46620-A

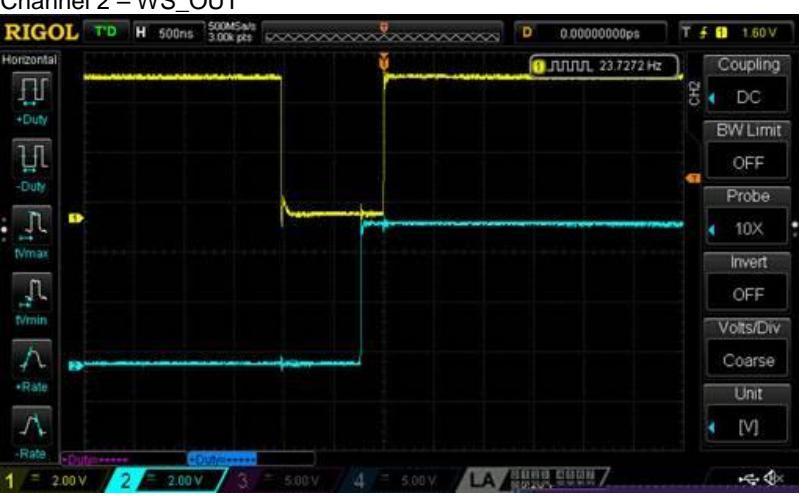
The output of the ACMP incorrectly goes low even when IN+ is greater than IN- if the RING OSC is active when the WS signal rises

Channel 1 – ACMP out Channel 2 – WS_OUT

Avoid using the RING OSC with the WS Controller, or add a filtering block on the ACMP output to filter out the glitch.

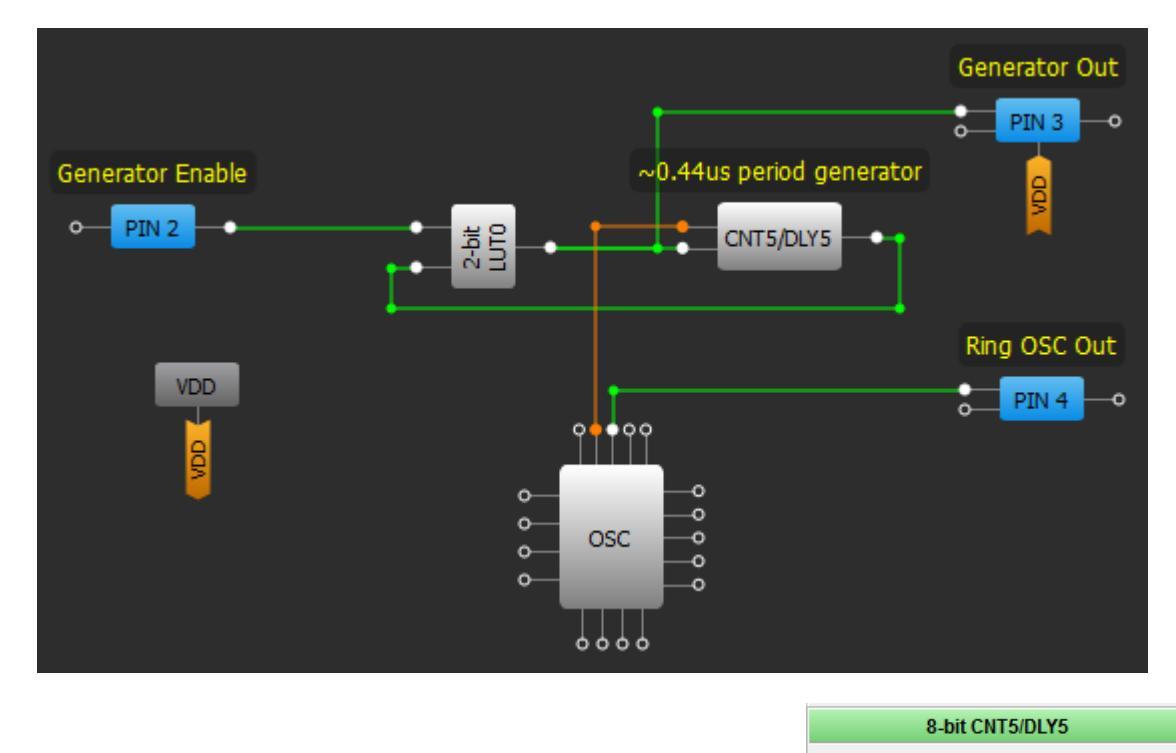
The Ring OSC has a longer settling time when configured as Auto Power On in the designs that have very short Ring OSC disable time. An example of this issue is shown in the following configuration:

- Set Ring OSC power mode to "Force Power On"
- or, Set Turn on by register option in BG (Band Gap) block as "Enable"

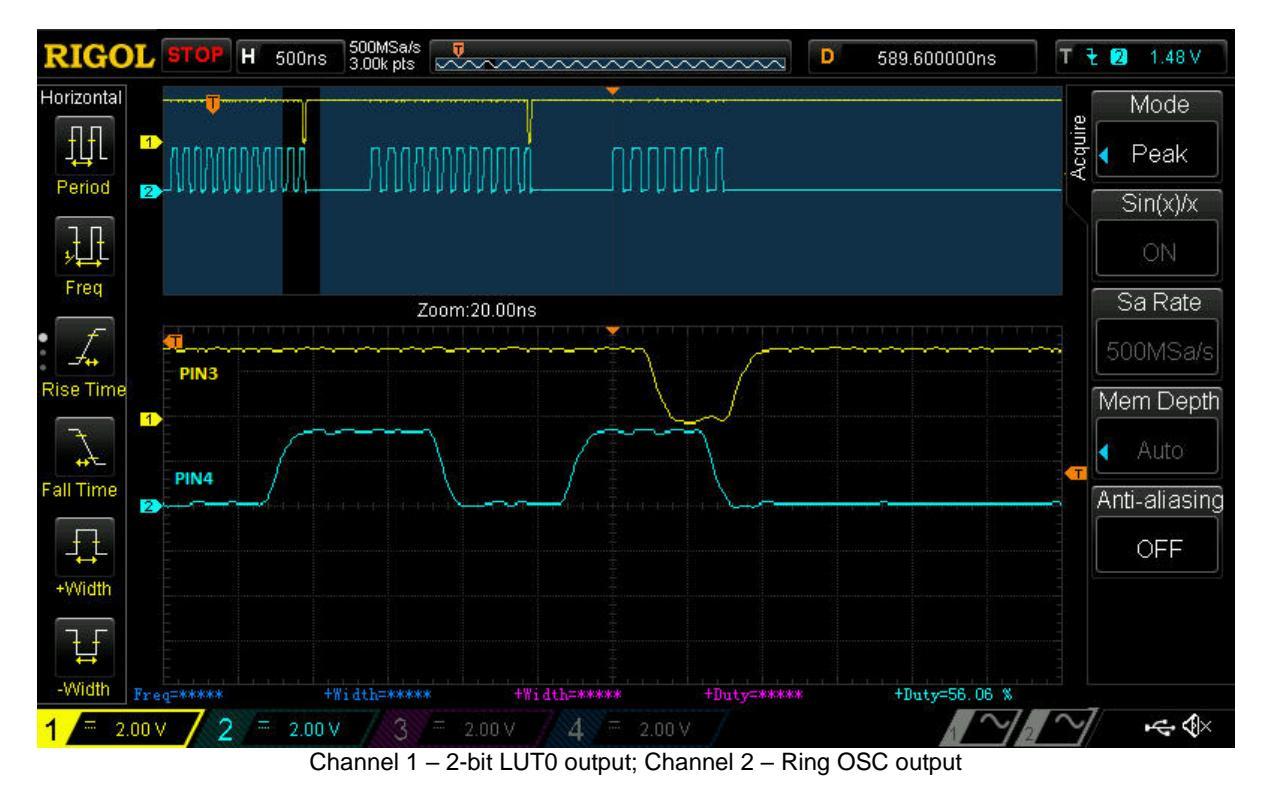
The configuration shown above generates a periodical signal with a frequency defined by the Delay cell and started by a high signal on PIN2. The issue becomes apparent in a longer settling time when the scheme generates short pulses (Delay is configured as a rising edge delay only). See waveform below.

Such behavior will lead to substantial error in period calculations if the delay time is relatively small.

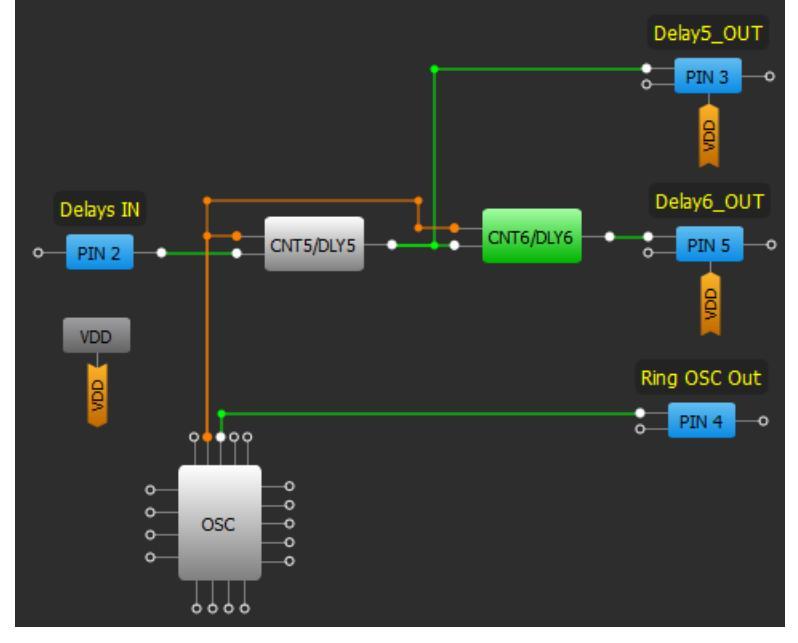
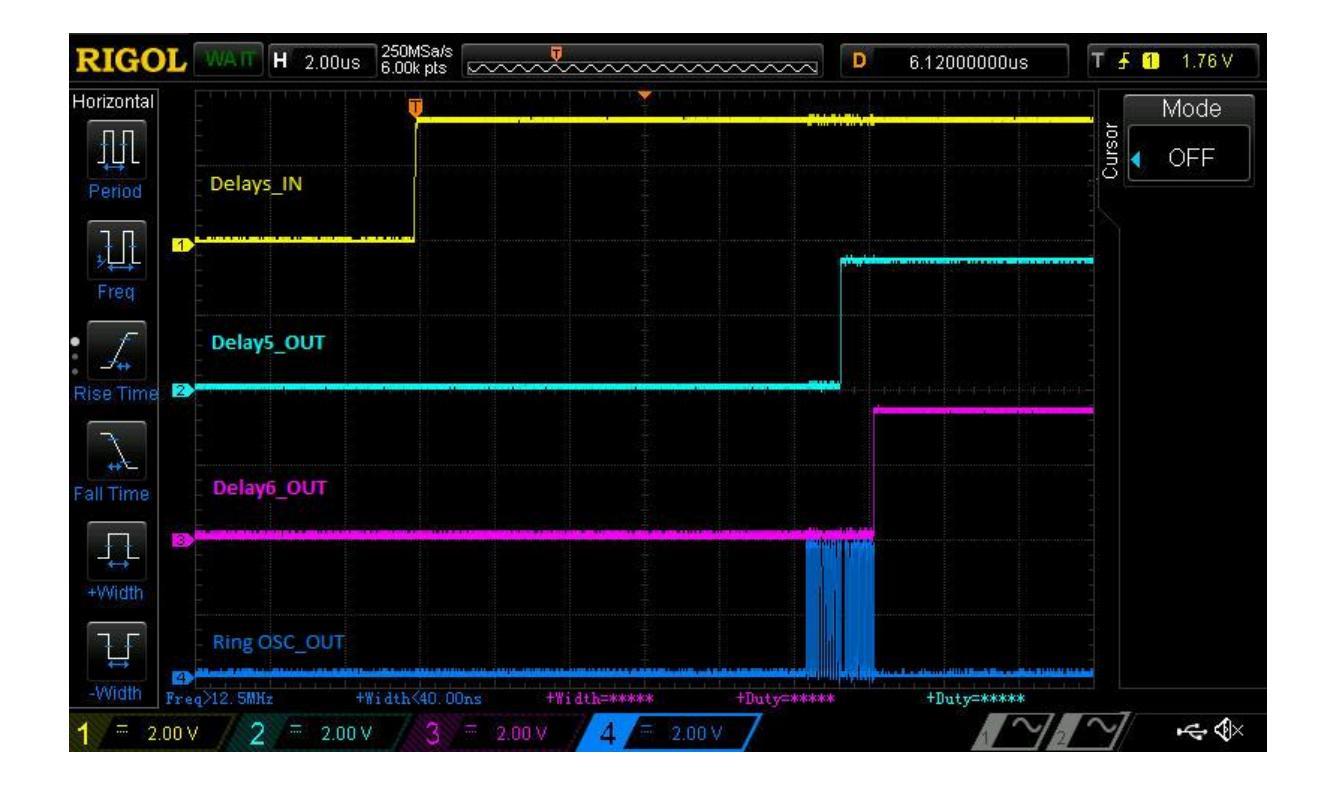
A similar situation can occur while using two connected delays (all edge detect types except for a pair "Rising edge DLY – Falling edge DLY").

In the following example, Delay5 and Delay6 are configured in the same way. However, Delay5 time is 11.4us instead of expected 0.4us (Delay5 time).

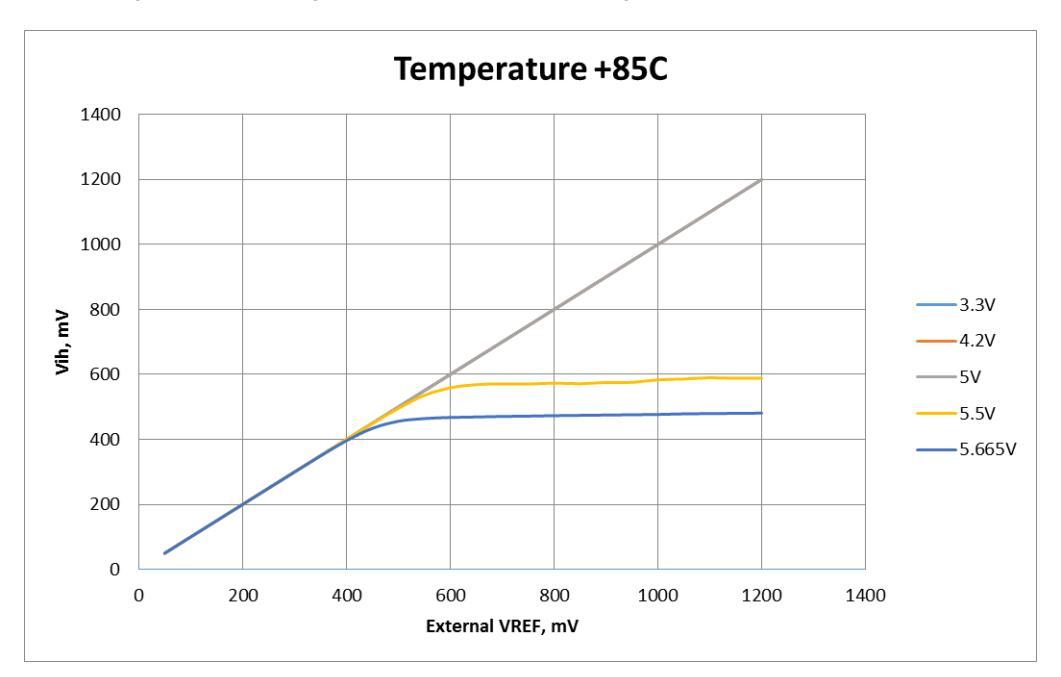
When using external Vref source, the ACMP comparison may happen at wrong threshold if the external Vref voltage is higher than a particular value (please see figure below) at high VDD values (> 5V) and high temperature.

Avoid using ACMPs in such conditions.

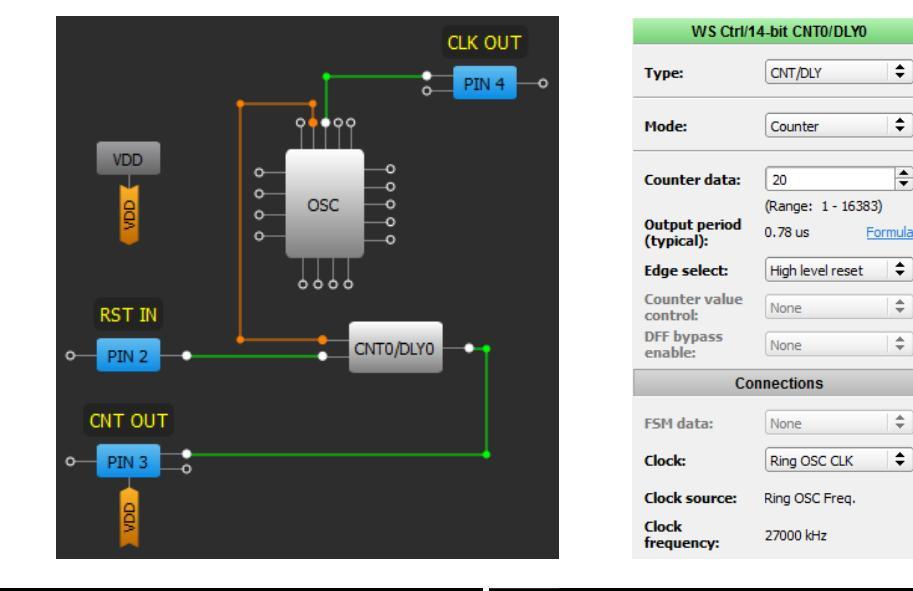
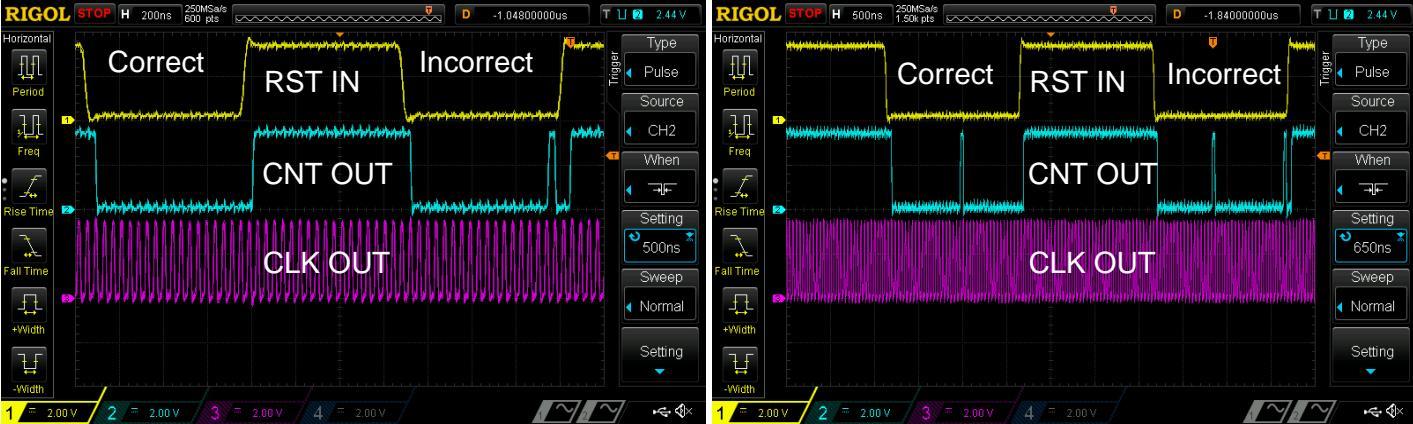
If the Counter Reset occurs at a time very close to a rising edge of the clock signal during clock signal generation (for example OSC operation), there is a possibility that the Counter Data of the Counter is reset incorrectly and the counter end signal (HIGH pulse) may appear faster than expected. This phenomena appears more frequently the higher the clock frequency is.

• Synchronize RESET input of the Counter with its CLK using 2 DFF cells as shown in the image below.

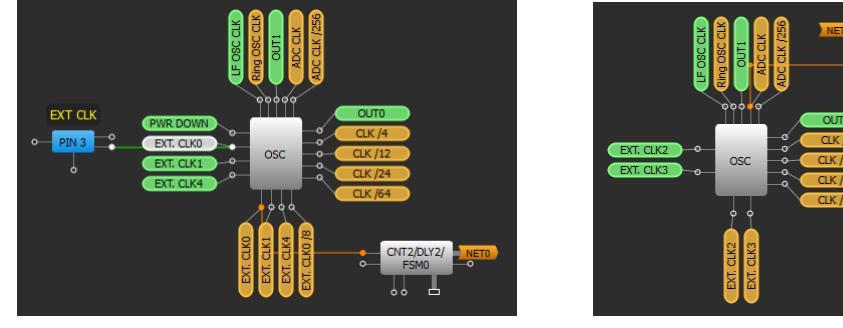
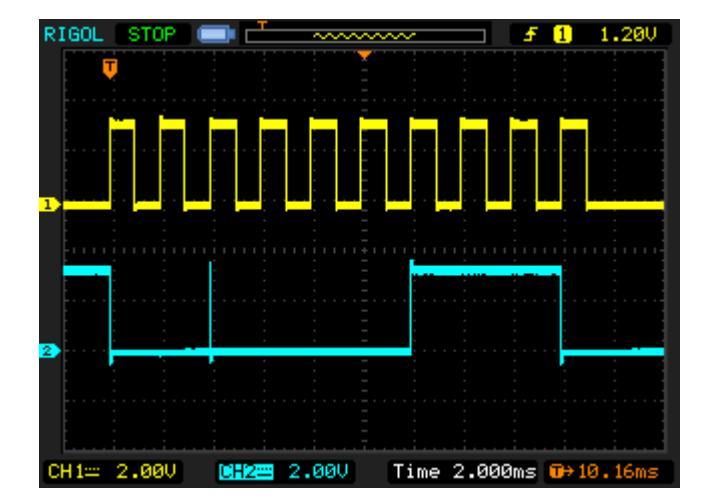
DCMP's OUT+ output may have a glitch when the input data is changed. This issue appears more frequently the higher DCMP clock is.

For example, DCMP IN+ sources from FSM0 and IN- from Register0. DCMP is clocked from the Ring OSC.

Synchronize the data source clock with the DCMP clock source using 2 DFF cells as shown in the images below.
