Product part number: SLG46200

Active SLG46200 Errata List

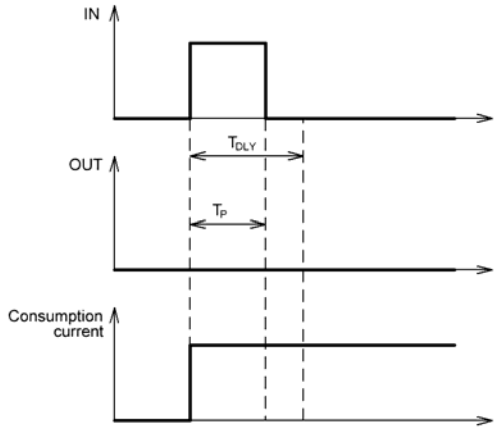
Incorrect Delay block (rising edge) functionality

If the delay input pulse duration is less than the delay time (other blocks do not use internal RC oscillator), the output will be correct but the power consumption will stay high. This is due to the delay block that starts RC OSC work after detecting a corresponding edge and then shuts it down after the delay time has passed. If the input signal duration (T_P) is less than the delay time (T_{DLY}), then the RC OSC won't shut down (delay cell will not give the RC OSC shut down signal internally) and the power consumption will go on. If any other delay cell or other block that uses OSC gives a shut-down signal then current consumption will stop.

Workaround:
Either force the unused Counter/Delay (configured as Counter) block on and put 1 to its register.
Or make special internal protection circuits which will make the delay block count to the end.

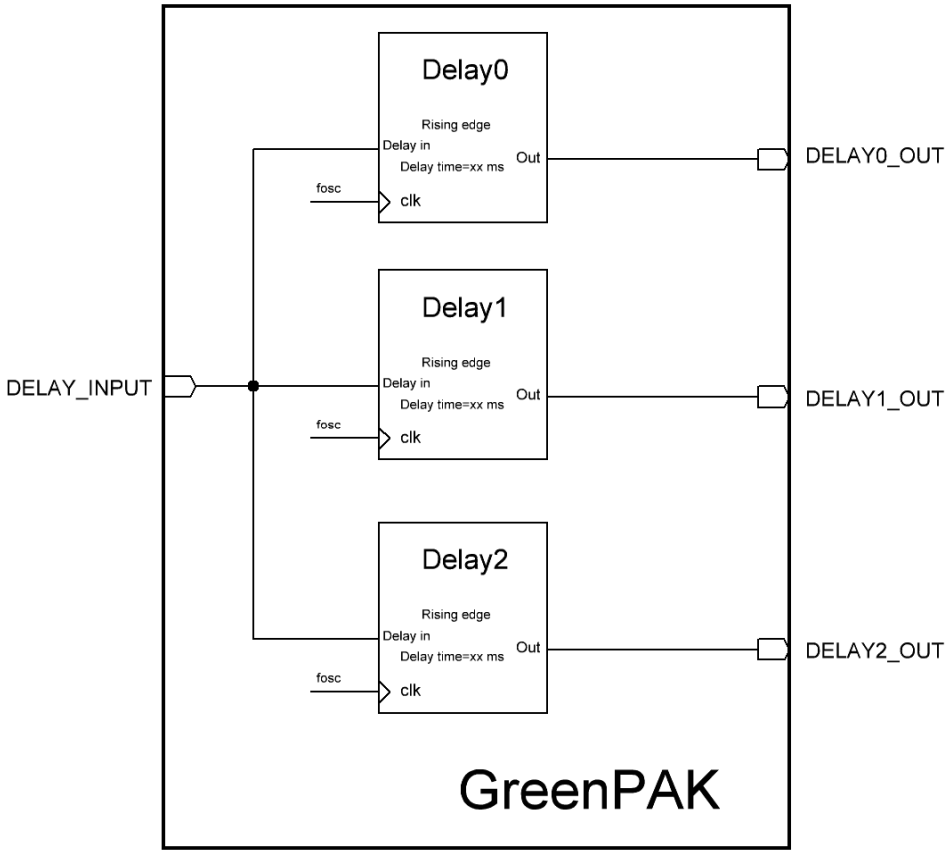
If time between two detected edges is approximately two times less than the delay clock period, then the input signal may pass to the delay output.

Workaround:
Use two Delay blocks in the series connection.

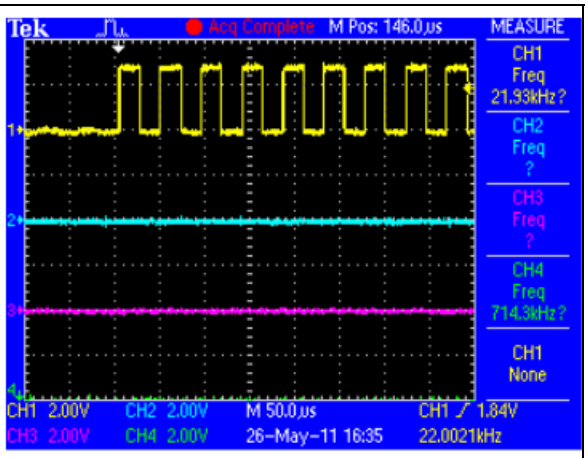
As an example the rising edge delay cell test results with internal RC oscillator frequency 43kHz are shown below.

ELAY_INPUT=22kHZ Delays function correctly	DELAY_INPUT DELAY0_OUT DELAY1_OUT DELAY2_OUT

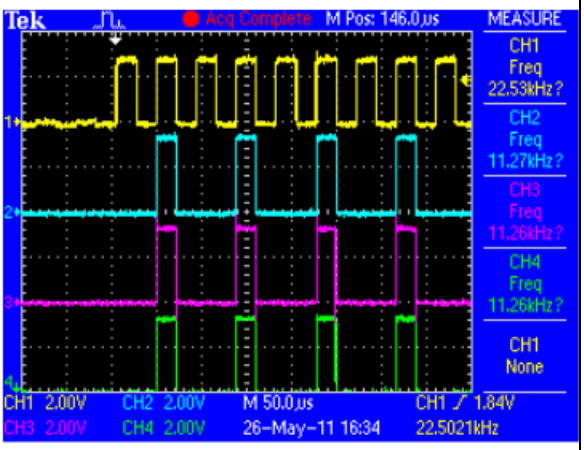
Delay_in=22.5kHZ (The input frequency value that causes incorrect functionality of delay blocks varies from chip to chip, duty cycle and delay clock value) Delays function incorrectly	DELAY_INPUT DELAY0_OUT DELAY1_OUT DELAY2_OUT

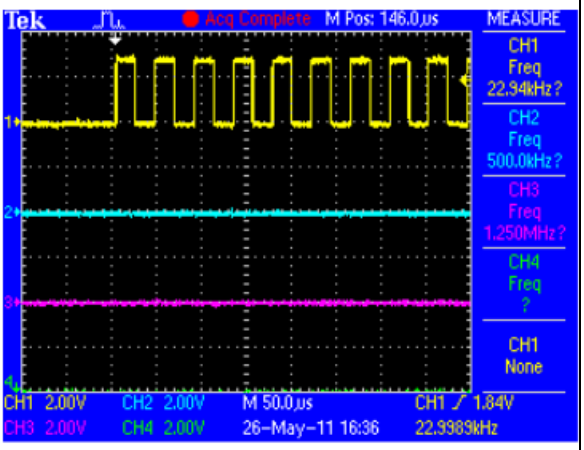
Delay_in=23kHZ Delays function correctly	DELAY_INPUT DELAY0_OUT DELAY1_OUT DELAY2_OUT

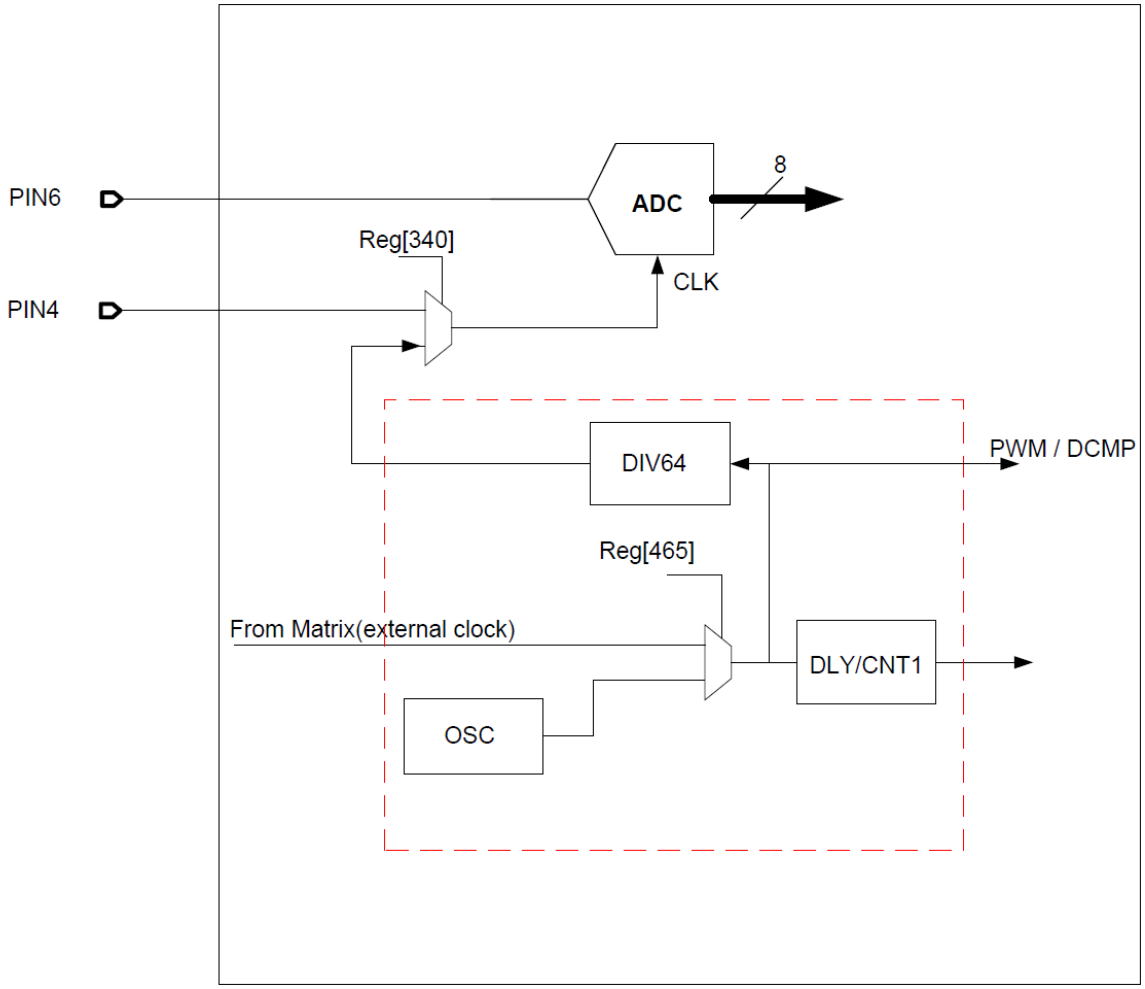
5. Analog-to-Digital Converter (ADC) using the Counter 1 clock.

The ADC uses Counter/Delay 1 clock source for sampling data. So if the Counter/Delay 1 clock is not connected, the ADC will not function at all.

Workaround:
Use the internal clock for Counter/Delay 1 for correct ADC functionality.
